Historic buildings Damp, rot and insect attack

The purpose of this leaflet is to look at damp, rot and insect attack in traditional buildings, the things which might be identified by a surveyor, valuer or other 'specialist', what the causes may be, how they might be tackled and where further advice can be sought.

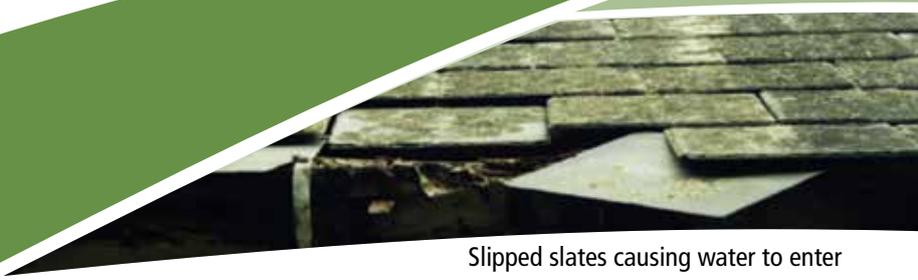
Slipped slates causing water to enter

Defective roof coverings and flashings are the most obvious source of water ingress. It is important to check that all coverings are sound and intact and that flashings are in place. If not, carry out the necessary repairs.

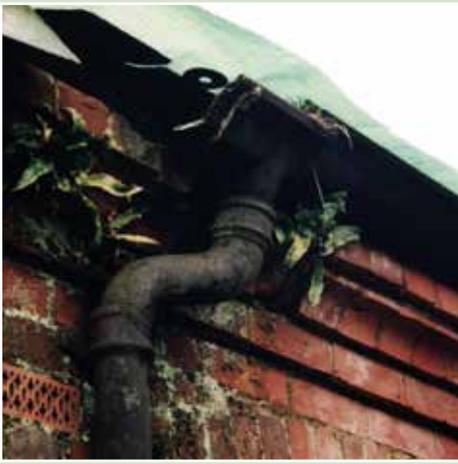
Repair and maintain gutters, downpipes and gulleys regularly to avoid problems with damp

Many problems regarding water ingress are related to drainage problems, caused by faulty rainwater goods. These must be repaired, downpipes cleared of debris and vegetation and falls on gutters must be in the correct direction. Gulleys must be clear allowing water to travel away from the building. These simple expedients alone would halt the majority of damp problems in walls at high level.

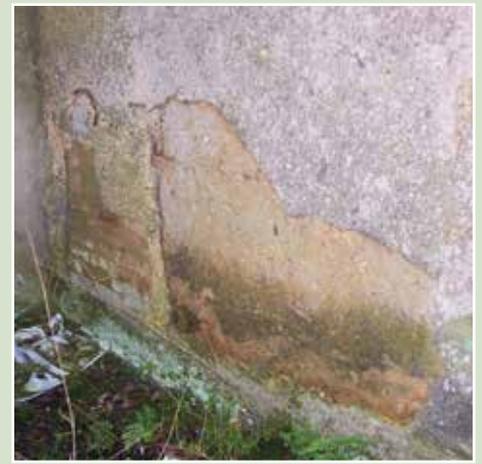
The lime render has cracked and fallen off allowing water to penetrate

Many buildings that were originally coated in lime render have been re-coated in cement, which is inflexible and impervious. It frequently cracks which means moisture can run behind the render where it collects and cannot evaporate back out. In time this can create a damp problem. It may be necessary to remove the render and replace it with a lime based render which is flexible and porous.

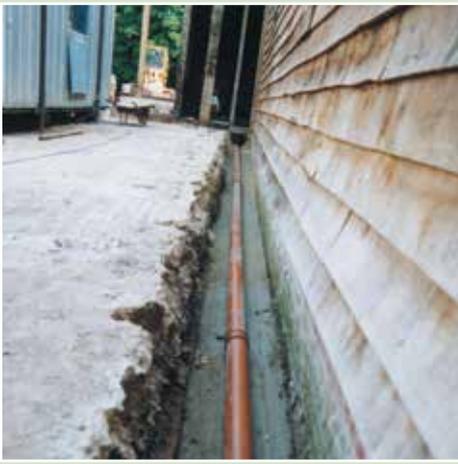
Creating a drainage channel to reduce ground water level against a wall.

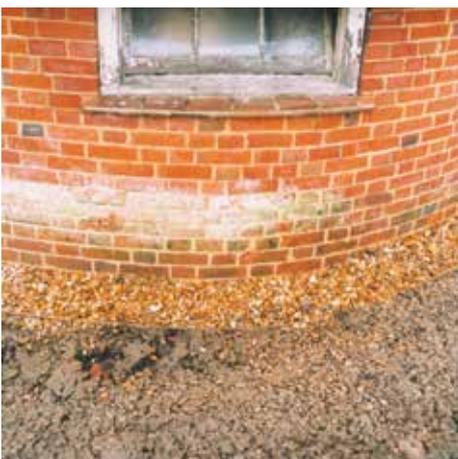
Land drain back-filled with shingle

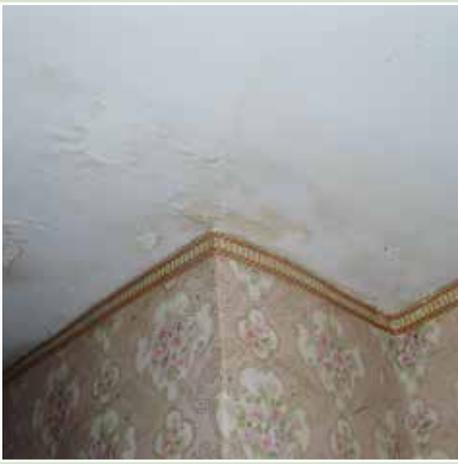
Example of damp penetration

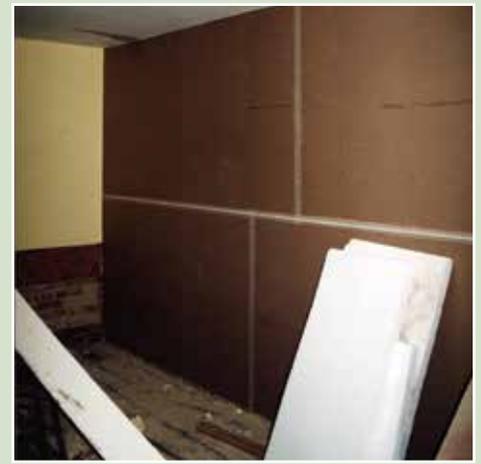
Dry lining

If it is not practical or desirable to install a damp proof course but rising damp, or unavoidable penetrating damp has been identified as the cause of unacceptable levels of moisture in the wall, it may be possible to consider dry lining. This could be carried out using stud framing clad with polythene sheet and plaster board or with plaster on expanded metal lath. It must however be properly isolated and the cavity formed ventilated, otherwise there is a real danger of dry or wet rot.

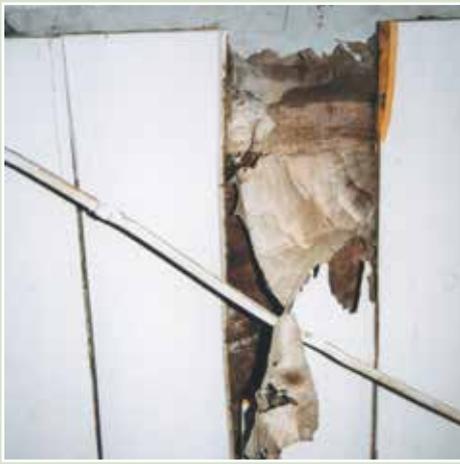
◀ Dry rot

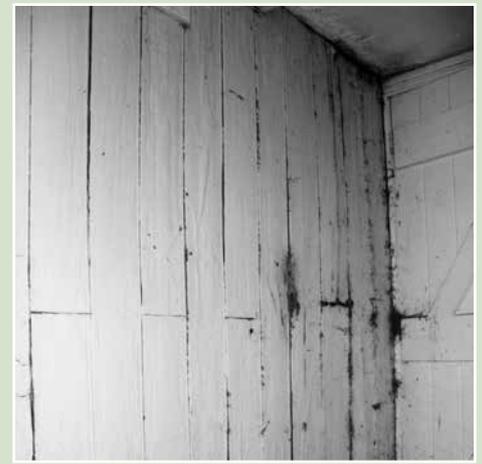
Moisture leading to damp ▶

Moisture leading to damp can come from a number of sources which have already been described in this leaflet. Essentially rot and insects will usually only cause damage where there is moisture. If the sources are not addressed and removed then deterioration will continue, whatever other action is taken.

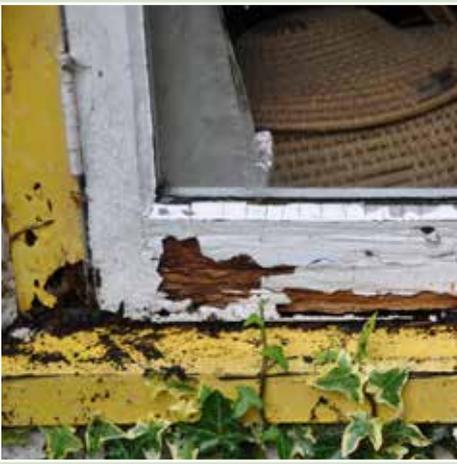
◀ Evidence of poor maintenance which has allowed water penetration, leading to rot

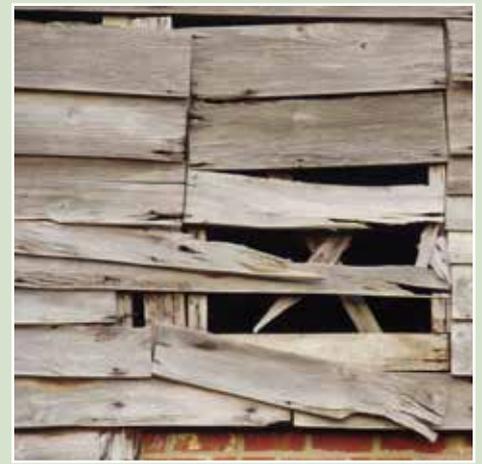
▶ If decay is localised, then localised methods of repair may be practical

If decay is localised, then localised methods of repair and, if necessary treatment, may be practical.

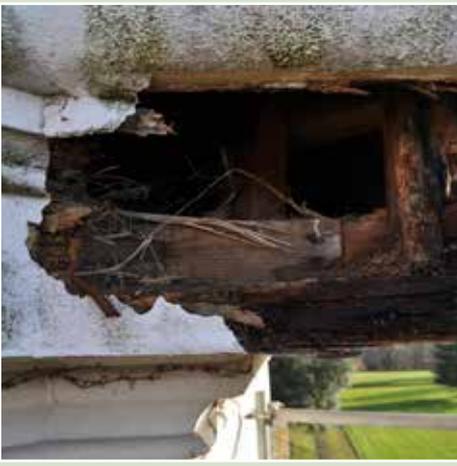
◀ Timber on this fascia has decayed to such an extent that it no longer performs its function and needs to be replaced

Once the extent of decay has been determined appropriate repairs can be undertaken. Timber which has decayed to the extent that it no longer performs its function will need to be repaired or replaced.

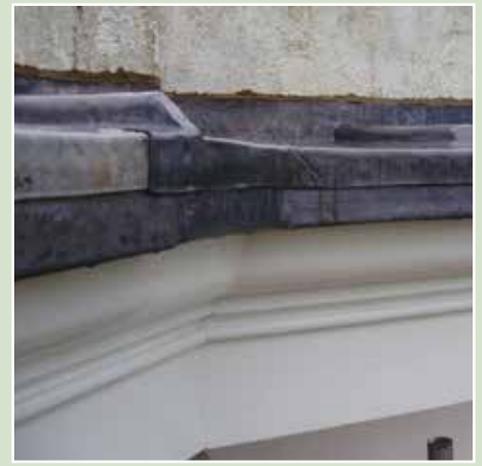
The same fascia following repairs ▶

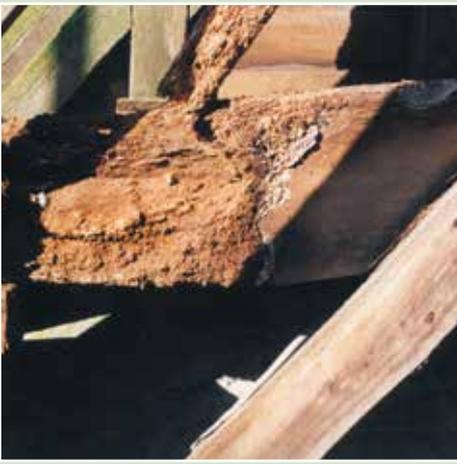
Wet rot followed by insect attack

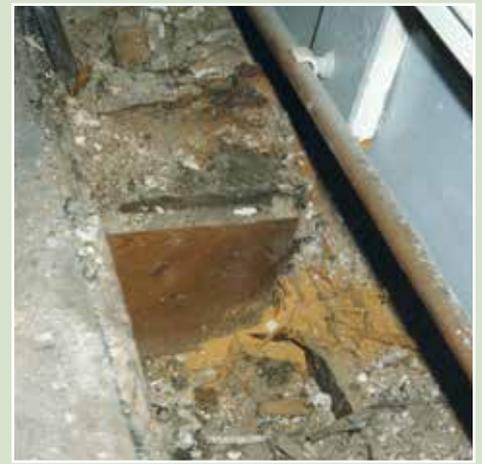
Localised repair was necessary to these sections of timber following an insect attack
