Historic buildings Flooring

This leaflet describes the materials, character and appearance of traditional flooring in the area as well as some of the problems encountered. It also offers suggestions on appropriate methods of repair.

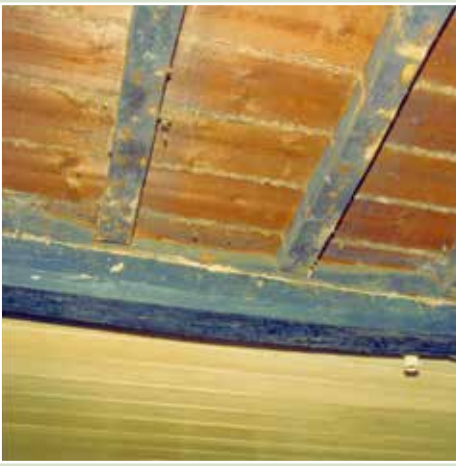
◀ A hardwood spine beam with softwood common joints and mid c19th softwood floorboards. Despite appearances both the boards and structural timbers are in excellent condition. This indicates that the design of the floor and the connection to the walls were well considered when the dwelling was built

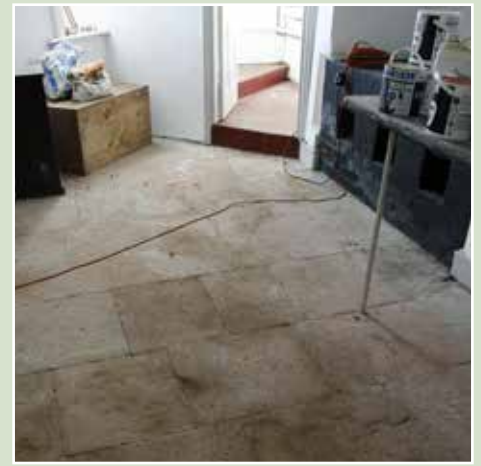
▶ Stone floor in a cellar, in good condition, which should be retained

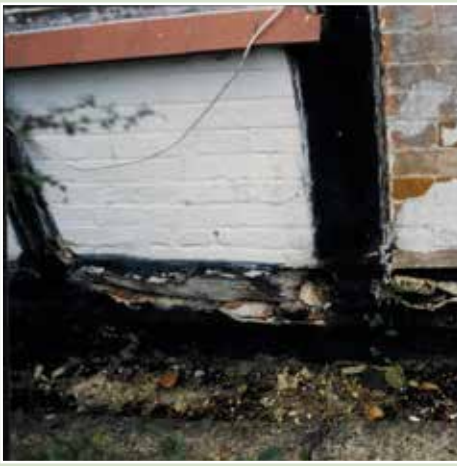
◀ A sole plate with no damp proof course has suffered from years of water penetration. The concrete channel beneath it serves to splash water onto it, adding to the level of moisture in the timber ▶

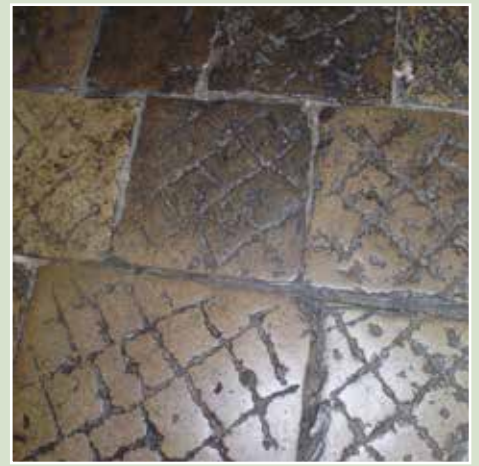
This fine stone floor is cracking, slightly uneven in part, but gives a cohesive feel to the room and should be left in its natural state. The unevenness of the material is far out-weighted by the positive character that it gives to the room

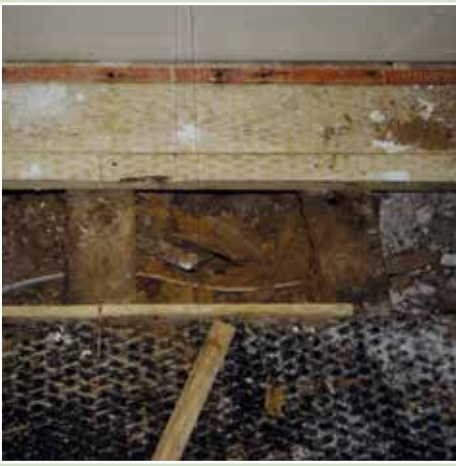
◀ A floor board replaced without addressing the problem of debris build up in the void below the boards. There are no air bricks in the wall and the debris continues to transfer moisture from the wall to the joists. The rot will continue to damage the substructure until it is cleared out and air bricks are introduced into the wall

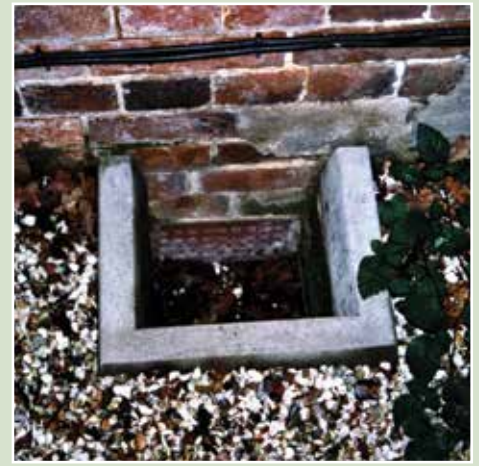
▶ Recently exposed, this air brick is now functioning as it should. However, the ground floor joists have rotted after years of no ventilation

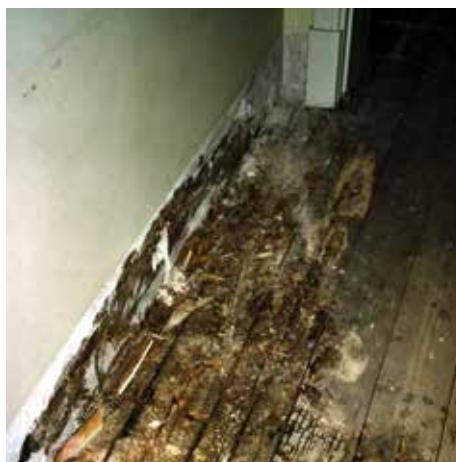
This outbreak of dry rot developed as a consequence of no through ventilation in the floor void

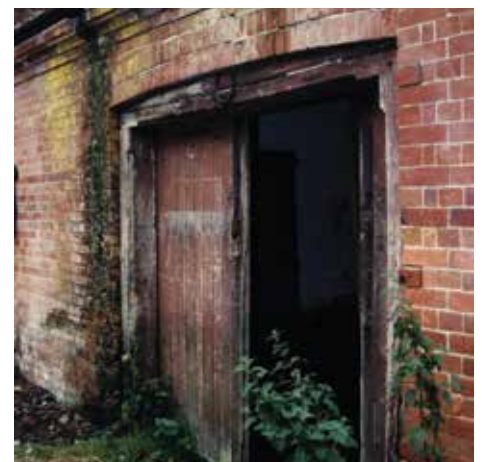
The guttering to this building is cracked in various areas. The result is severe moisture damage, dampness within the building and erosion of the brickwork

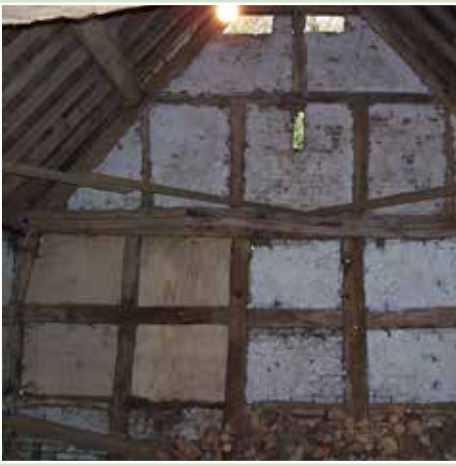
◀ The joint between the frame and infill panels may move allowing moisture to enter the building

- In timber framed structures, the joint between the frame and the brick infill panels may move and crack. Moisture might then be driven in.

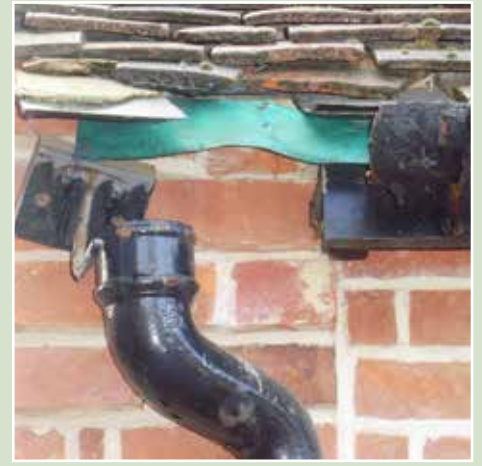
Faulty gutters and leaking downpipes may lead to saturated walls and floors ▶

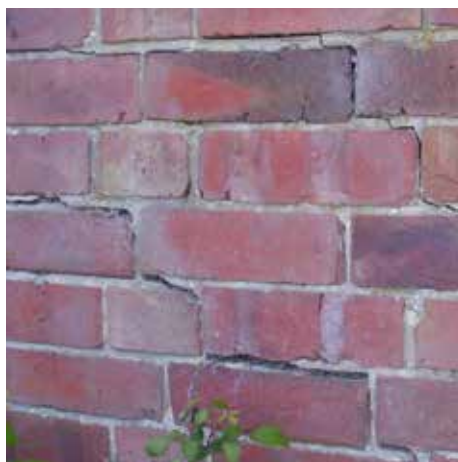
Failed pointing in brick walls can allow driving rain to penetrate

- Failed pointing in brick walls can allow driving rain to penetrate.
- Waterproof cement render can fail, allowing water to penetrate behind it, which in time becomes drawn into the fabric of the structure.

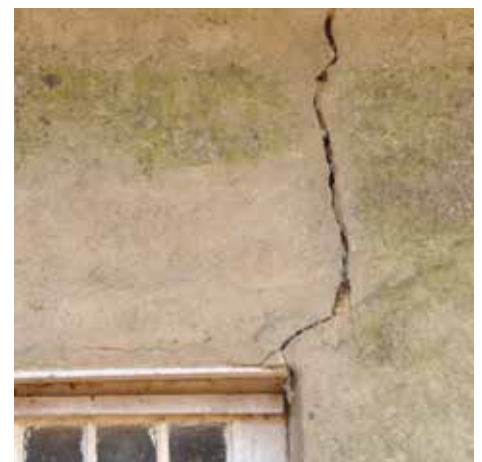
Lack of general maintenance can lead to a break down of the fabric allowing ingress of moisture

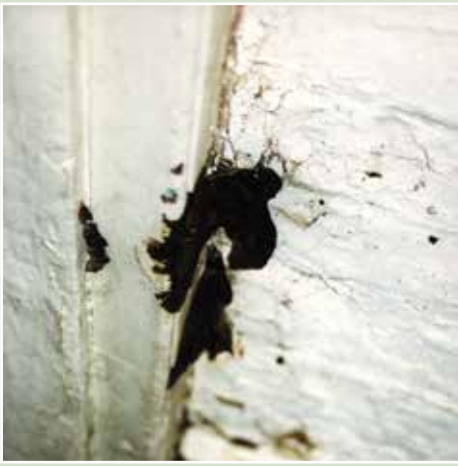
A fruiting body at the base of a door frame. Despite the floor being tiled, dampness in the floor structure has led to dry rot in the door frame

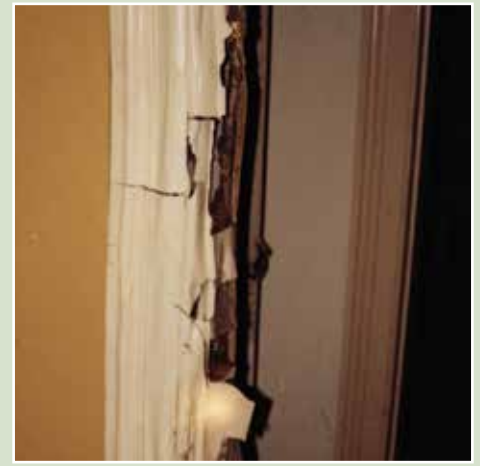
The brittle cracked timber door lining is affected by dry rot, which appears to have crept up from the floor

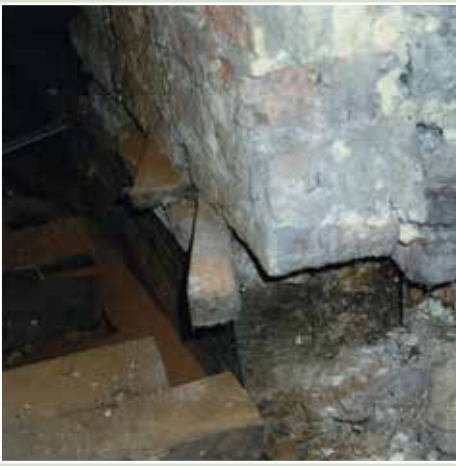
The dusting seen on the wall plate signifies severe Deathwatch Beetle infestation. Even though the sections of timber appear sound, the ends have been eaten away

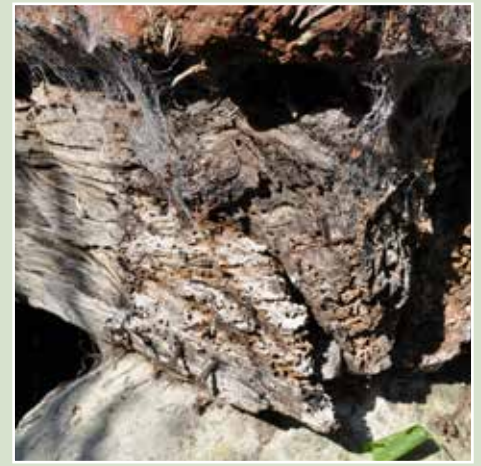
Example of wood badly affected by furniture beetle

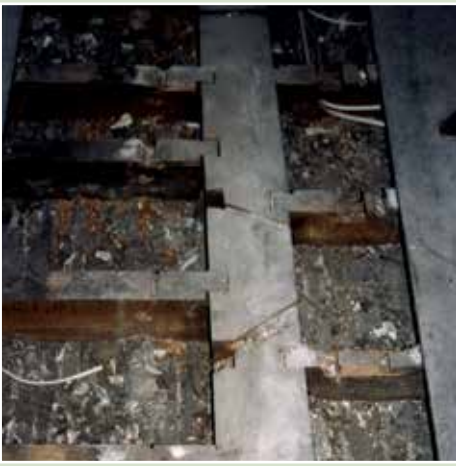
Old common joist slots have been avoided when the newer, Victorian joists have been inserted. Although a neater joint is created, this practice effectively weakens the integrity of the main spine beam. Notches created by plumbers and electricians further weaken the spine beam

- The joint made between the joist and the main beam can be weak, of insufficient depth, or shrunken away.
- Another reason is based on previous interventions, when old joists have been removed and replaced in newly cut slots in the spine beam. This leaves the spine beam with various notches, all of which reduce the tensile strength of the timber. (Modern alterations like this still occur when electricians or plumbers insert cables or pipes through a floor joist.)

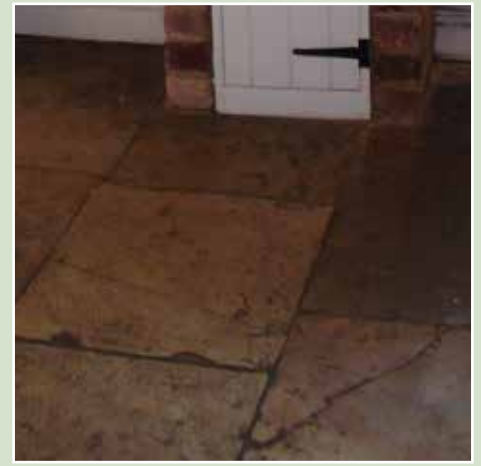
Fine stone flooring in a listed cottage - replacing it would need listed building consent

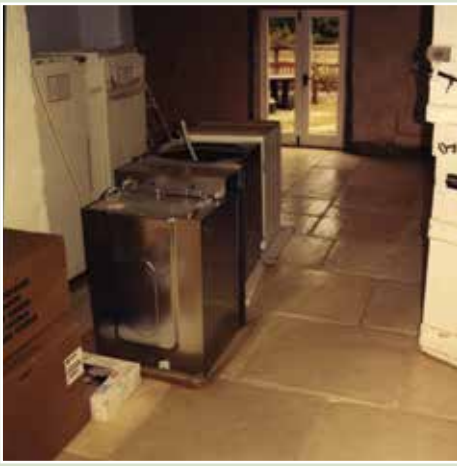
This is how not to do it. This reconstituted stone floor was laid without listed building consent and is wholly inappropriate in a historic building. Poor substitute materials are rarely suitable and should be avoided

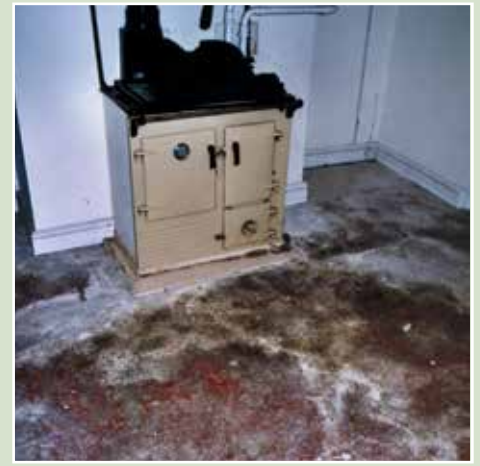
Whilst this is probably a pre-war concrete floor it is still nevertheless a pity to have removed the timber. Damp ingress and/or rot probably caused its removal

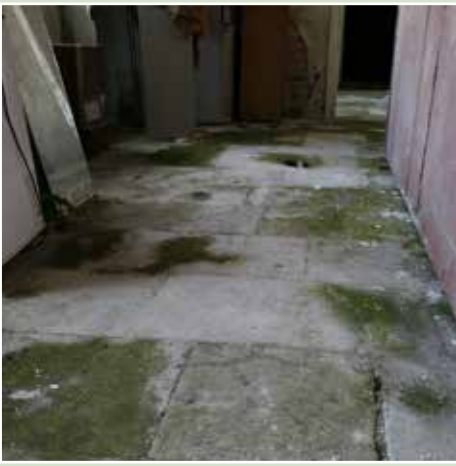
Much of the flooring in historic buildings is slightly damper than we would expect in modern flooring material

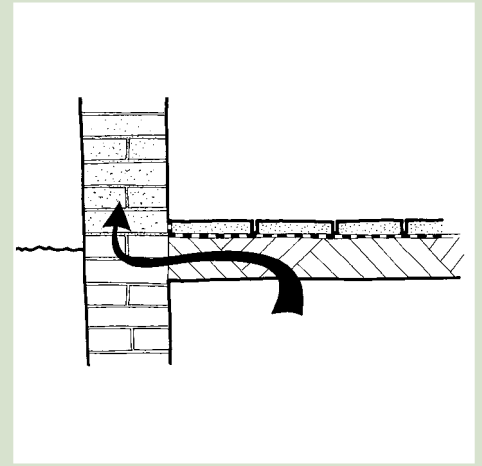
The insertion of a damp proof membrane underneath the tiled floor has caused moisture to be driven up the walls

It must be recognised that by inserting a dpm moisture will be driven away from the floor and up the walls. This must therefore be considered before lifting the floor.

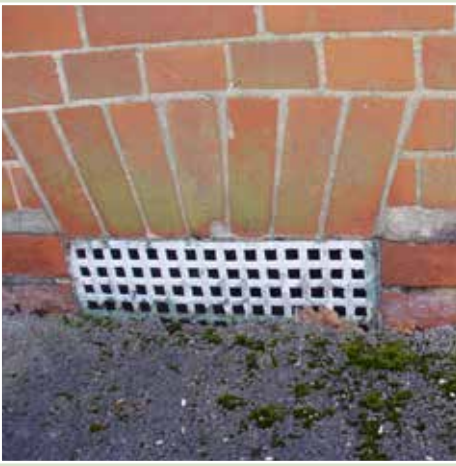
◀ Air bricks should be kept free of leaves and debris to allow a good through flow of air. In this example, the pavement has been applied right up to the air brick, reducing its efficiency

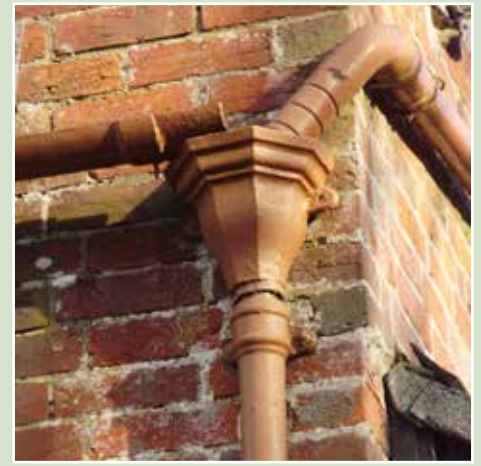
▶ Rainwater goods should be maintained on a regular basis

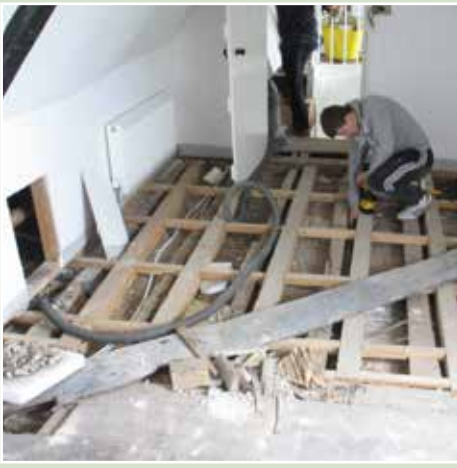
Remedial works being carried out to support a wooden floor at first floor level.

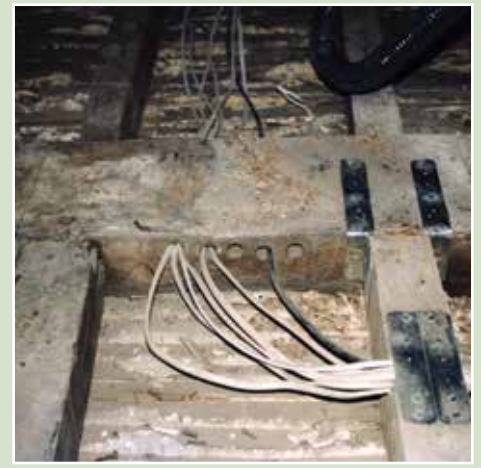
The insertion of electric cables and water pipes can seriously damage the structural integrity of a floor. This common joist has been strapped across to increase bending capability and has been attached to the spine beam using a 'joist hanger' to reinforce the original, and now rather weak, structural connection into the beam

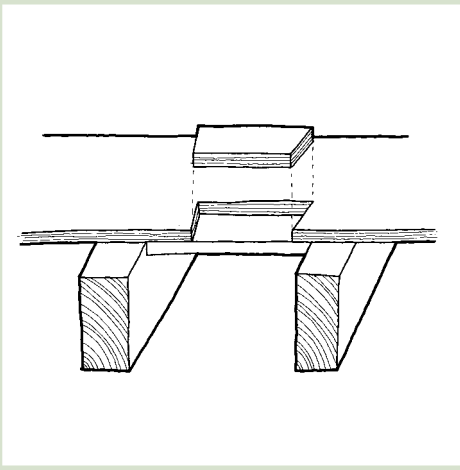
◀ A supporting timber located between the joists will carry the load and help consolidate this repaired section of board

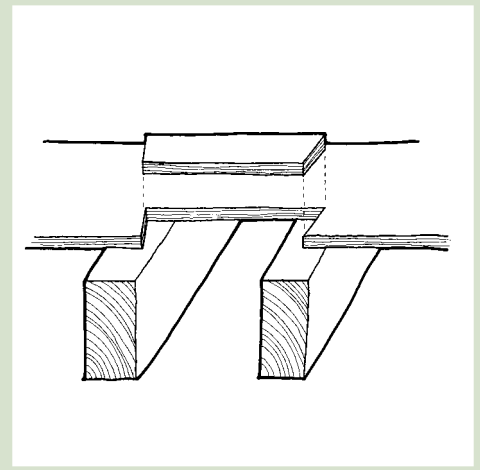
▶ When a repair is bigger, the joists themselves can carry the ends of the new section of board
